Maryland Historical Trust Addendum to Maryland Inventory of Historic Properties Form

Inventory No. **QA-369**

Sylvester Farm Tenant House
Queen Annes County

INVENTORY FORM FOR STATE HISTORIC SITES SURVEY

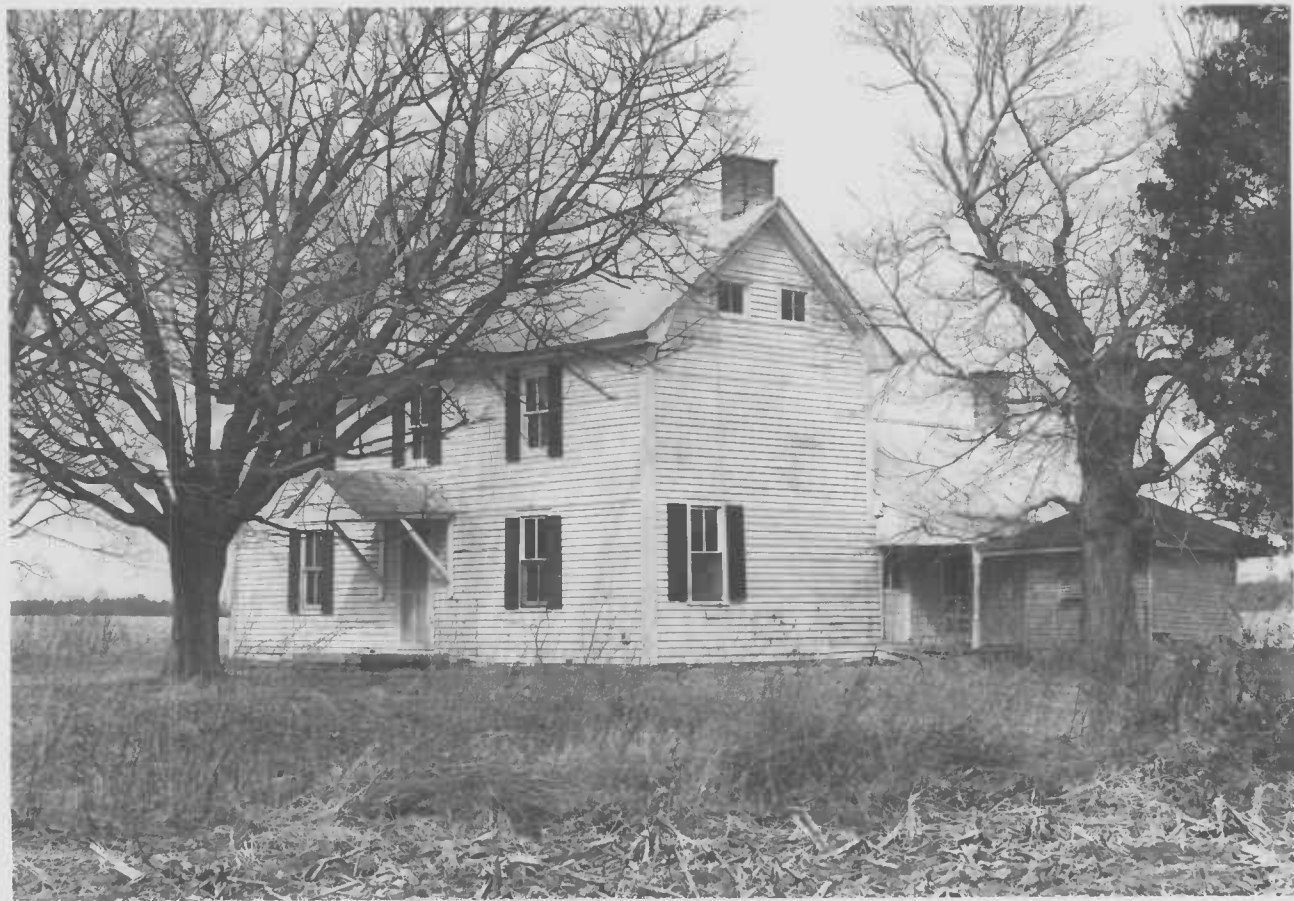
View From Southeast

The principal facade faces south, with the entrance door located in the center bay, flanked by a pair of two-over-two windows. Three two-over-two windows are symmetrically arranged on the second floor. A small entrance hood projects over the door, probably replacing an earlier one story porch. The door is paneled, with a three-light transom but no sidelights. Siding consists of plain horizontal weatherboards with

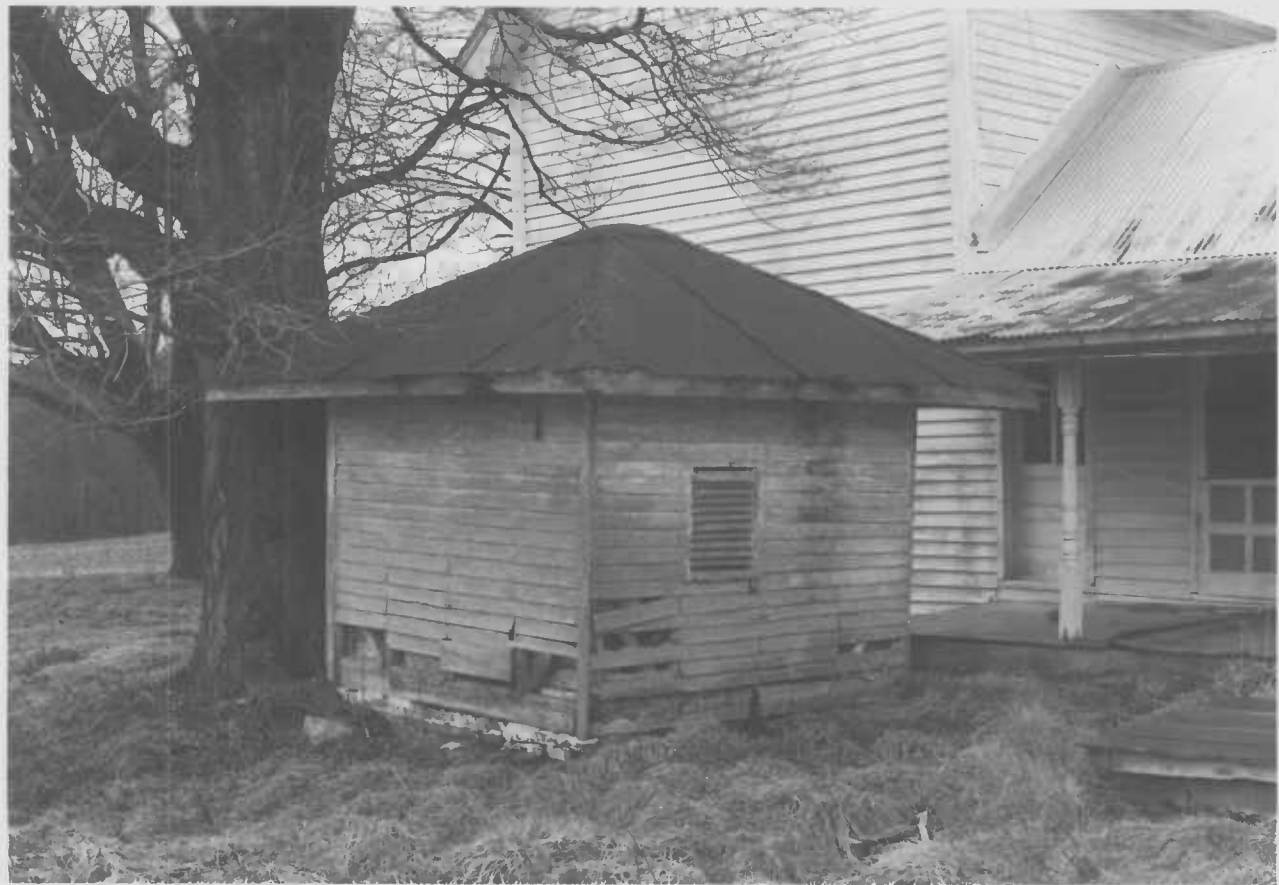
In addition to the house, there is a small frame dairy that retains the original riven clapboard siding on three exterior walls. The clapboards are secured with machine nails, and this, combined with framing details, suggests a date in the mid-19th century. This is a relatively late survival of clapboards and suggests that they

Directly to the east of the house is a small frame dairy with an overhanging pyramidal roof. It is 8 feet square and rests on a continuous brick foundation. There is a plain batten door located in the west facade, and louvered ventilator windows in the north and south walls. Four holes have been drilled in the batten door to increase air movement. The roof is tin, and the eaves are left exposed, with a fascia board nailed to the mitred rafter ends. The interior is plastered, using machine sawn lath and machine nails.

What is distinctly unusual about this building is the form of siding. The east wall is covered with plain, machine sawn horizontal weatherboard. At first glance, the remaining three walls appear to be similarly covered, though with slightly narrower boards. A closer examination, however, reveals that these three walls are actually covered with riven clapboards secured with machine nails. These are very finely made, and are sufficiently smooth and regular to be mistaken for sawn boards. They average only four feet in length, however, and the numerous vertical seams on an 8 foot wall are the first clue that this is not typical siding.

Dairy w/ riven clapboard siding
